INFRASTRUCTURE MANAGEMENT PLAN

NARRATIVE REPORT

BOROUGH OF CONSHOHOCKEN

September 28, 2018

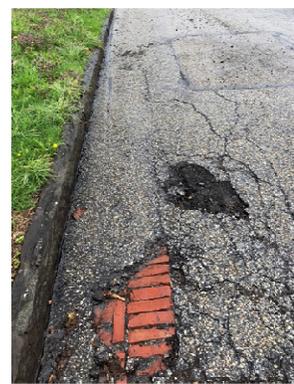
**Hallowell Street
(East 3rd-East 4th)**

When constructing a roadway with gutter curb, the curb and gutter are typically installed first on either side of the roadway. The pavement is then installed between the gutters so that the elevation of the centerline is higher than the gutter and water flows towards the edge of the roadway. As you can see in the pictures on either side of the page, gutter curb can be fashioned from a combination of several different materials such as concrete, brick, granite, etc. For example, East 9th Avenue between Jones Street and Righter Street (Block 76) was constructed with a concrete curb and gutter while Hallowell Street between East 3rd Avenue and East 4th Avenue (Block 325) was constructed with a granite curb and a brick gutter. Replacement of gutter curb with standard upright curb therefore requires the somewhat costly removal of the gutter and replacement with a full roadway pavement cross-section.

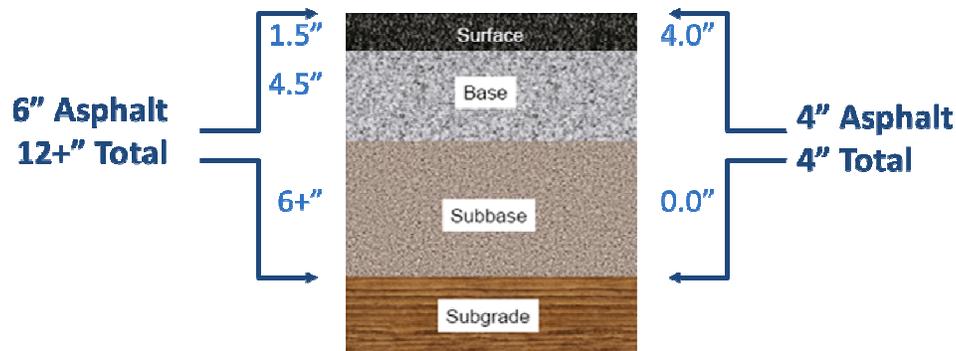
FIGURE 4.1: CORE SAMPLE RESULTS - PAVEMENT CROSS SECTIONS

The core sampling revealed drastic variations in the pavement conditions throughout the Borough. For example, the core samples taken from West 11th Avenue between Wood and Maple Streets (Block 22) and East 11th Avenue between Harry and Hallowell Streets (Block 29), detailed on the left side of the figure below, show that these blocks were constructed with a cross section similar to that of the Borough's current roadway paving standard, which requires a 1-½ inch thick wearing course, 4-½ inch thick base course, and 6 inch stone subbase. The core sample taken from East 11th Avenue between Jones and Righter Streets (Block 35), detailed on the right side of the figure below, indicates that the existing roadway surface was constructed with only 4 inches of asphalt that was placed directly on the subgrade with no stone subbase.

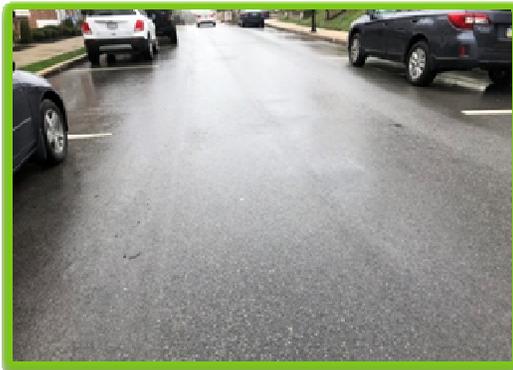
E. Hector Street (Typ.)

Based upon our condition assessment, we are recommending that 69 of the 355 blocks (19.4%) receive a crack sealing treatment. The pictures below were taken along East Hector Street (Blocks 212-213 and 216-217), Maple Street (Blocks 270-272 and 247-81) and East 3rd Avenue between Harry Street and Hallowell Street (Block 167). These blocks are excellent candidates for crack sealing because the roadway surface is still in generally good condition but is starting to exhibit signs of minor longitudinal and traverse cracking.

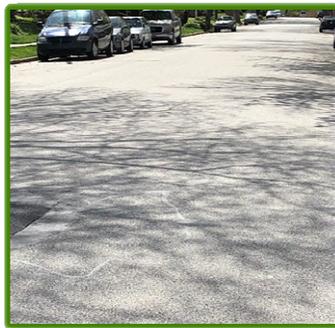
E. 11th Avenue (Hallowell-Wells)

Based upon our condition assessment, we are recommending that 34 of the 355 blocks (9.6%) receive a micro-surfacing treatment. The pictures below were taken along East 11th Avenue between Hallowell and Wells Streets (Block 31) and East 5th Avenue between Wells Street and Spring Mill Avenue (Block 143). These two blocks are being recommended for micro-surfacing because they are exhibiting signs of raveling/polished aggregate with areas of minor longitudinal or traverse cracking.

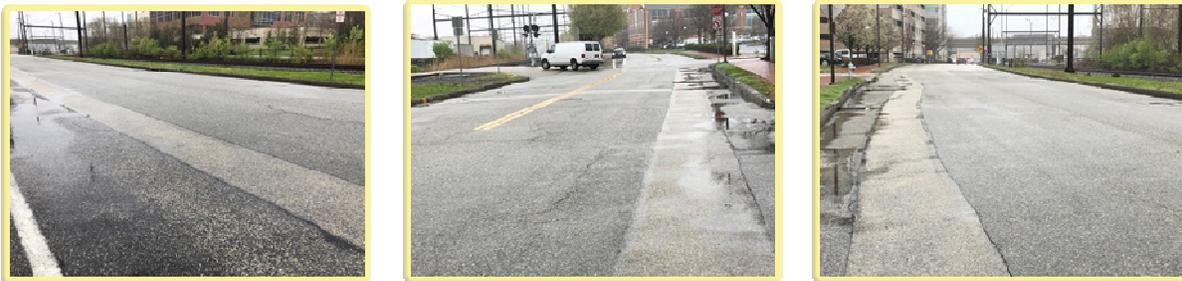
Washington Street (Harry-Ash)

Based upon our condition assessment, we are recommending that 125 of the 355 blocks (35.2%) be treated with a basic mill and overlay. The pictures below were taken along Washington Street between Harry and Ash Streets (Block 234). This block is a perfect example of a road that should be resurfaced. As you can see, there is minor longitudinal cracking, a slight drainage issue by the inlet, and minor settlement along the utility trench. Based on the distresses seen at the pavement surface, it appears that the base and subbase are in good condition.

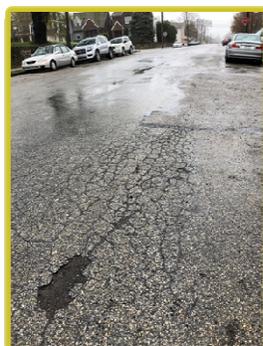
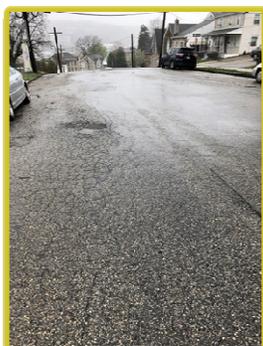
**Mill & Overlay with Minor Base Repair
Hallowell Street (E. 4th-E. 3rd)**

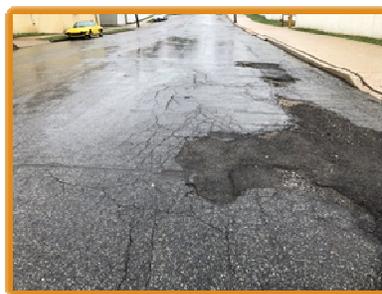
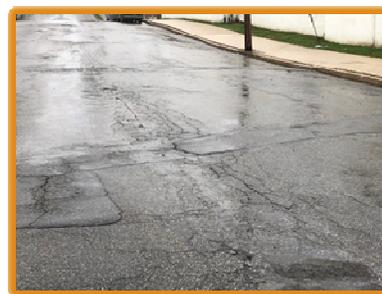
**Mill & Overlay with Moderate Base Repair
Jones Street (Spring Mill-E. Hector)**

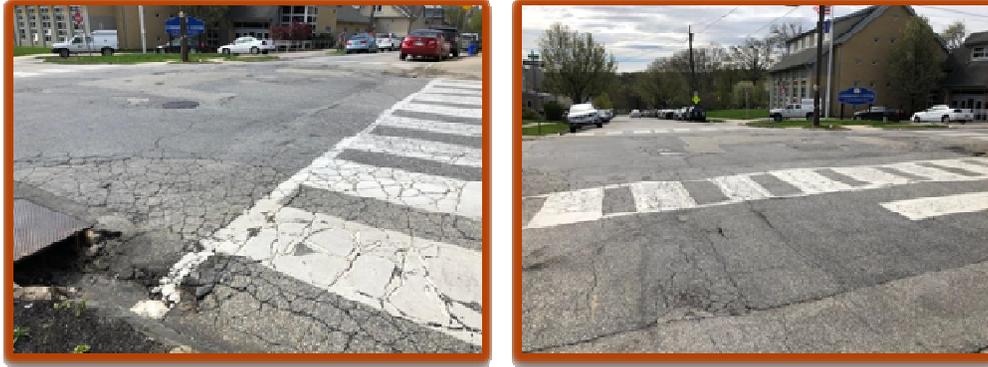
**Mill & Overlay with Major Base Repair
East 6th Avenue & Harry Street**
