INFRASTRUCTURE MANAGEMENT PLAN

NARRATIVE REPORT

BOROUGH OF CONSHOHOCKEN

September 28, 2018

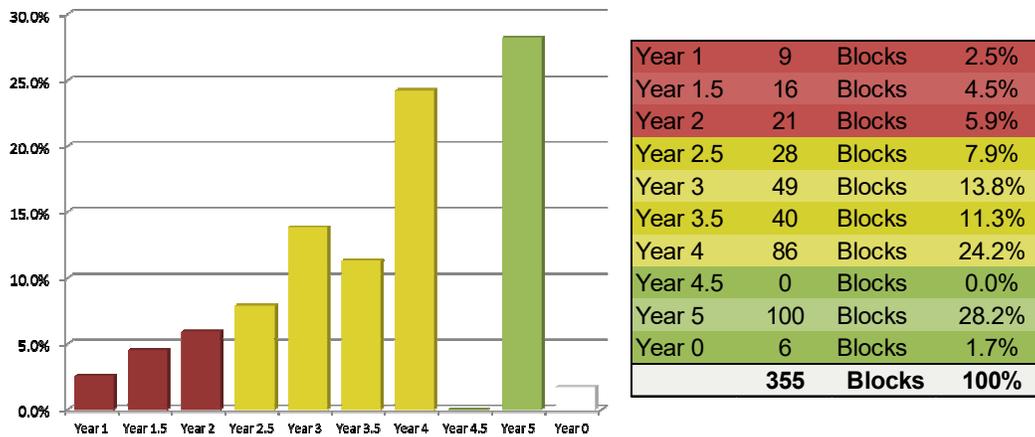
FIGURE 1.1: REPAIR YEAR RATING

Based on the initial repair year ratings and a 5-year time line, Figure 1.1 on the following page provides the following recommendations:

1. 6 of the 355 blocks (2%) need no treatment;
2. Treat 100 of the 355 blocks (28%) after Year 4 since these blocks appear to be in acceptable condition;
3. Treat 203 of the 355 blocks (57%) between Year 2.5 and Year 4 to prevent further degradation and avoid larger, more costly repairs; and
4. Treat 46 of 355 blocks (13%) within the first 2 years since the pavement has degraded to a point where major repairs or full reconstruction is required.

The repair year ratings shown above in Figure 1.1 were ultimately used as a guideline to create the implementation scenarios described later in this report. A Pavement Repair Year Map identifying the recommended repair year for each block can be found in Appendix A of this report.

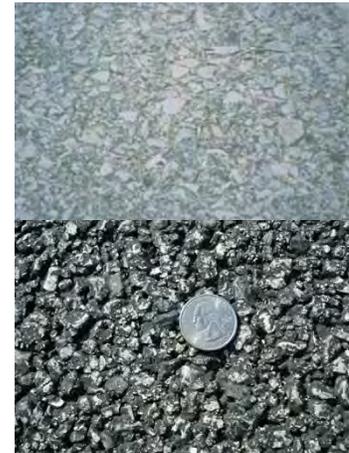
2.3.1 Raveling/Polished aggregate

Pavement surfaces are considered to have polished aggregate once the binder in the asphalt has been worn away and exposes the individual stone particles. Polished aggregate is considered a pavement distress because the roadway surface becomes smooth and slippery in damp or wet weather conditions. Once the aggregate is exposed the pavement surface continues to degrade, starting with the finer aggregate washing away leaving pock marks followed by the dislodging of the larger coarse aggregates leaving a rough and jagged roadway surface. The level of raveling can range from only the loss of smaller fine aggregates to the loss of the larger coarse aggregate which will ultimately result in a rough and pitted surface. Roadway surfaces experiencing polished aggregate or raveling can be repaired by applying a thin asphalt overlay, chip seal, slurry seal or micro-surfacing to restore the asphalt binder at the surface.

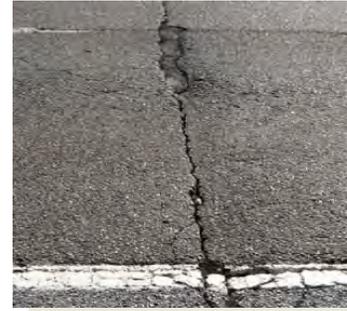
2.3.3 Transverse cracking

Transverse cracking is typically a single crack that develops across the roadway, perpendicular to the centerline of the road that is not associated with vehicle loading. This type of cracking can be caused by the contraction of the surface layer due to temperature changes, an existing crack in an underlying pavement layer, or the movement of an underlying pavement layer. Similar to the longitudinal cracking, minor transverse cracks can be sealed to prevent moisture from penetrating the subbase and areas with more severe cracking may require a mill and overlay.

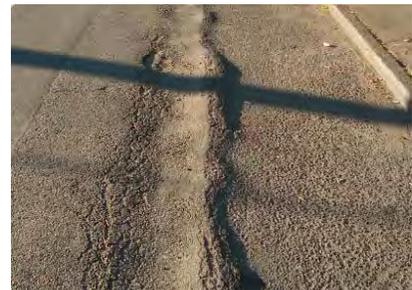
2.3.4 Rutting

Rutting is a longitudinal depression in the roadway surface typically found in the vehicle wheel path. Rutting is generally a result of the consolidation or movement of a pavement layer under vehicle traffic and can be caused by insufficient pavement thickness, poor compaction, or moisture infiltration. Minor rutting can be repaired by filling the depressions with asphalt and placing an asphalt overlay while areas of severe rutting should be repaired using a partial or full depth replacement patch or base repair.

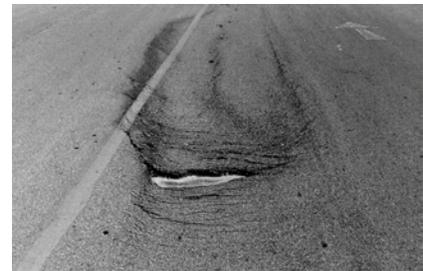
2.3.5 Shoving

Shoving, also known as wash-boarding, is the displacement of asphalt and the formation of ripples in the pavement. Shoving typically occurs because of movement in a pavement layer under vehicle traffic and can be caused by a pavement layer that is too thick, tack coat not being properly placed between asphalt layers to bond them together, or a weakened base course. Shoving is most commonly seen on hills and at intersections and is repaired by using a partial or full depth replacement patch or base repair.

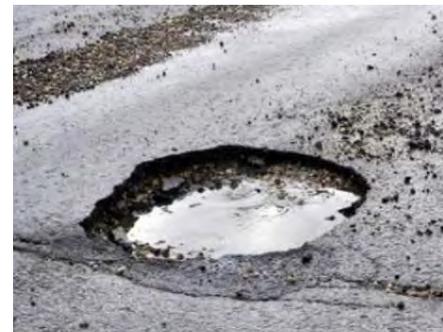
2.3.6 Potholes

Potholes are bowl-shaped depressions in the roadway that penetrate all the way through the surface layer of the roadway down to the base course. While sizes and depths may vary, potholes are usually identified by their sharp edges and vertical sides at the pavement surface. Potholes begin to develop from any of the pavement distresses mentioned above, and are accelerated by moisture penetrating the subbase and/or subgrade and the freeze-thaw cycle. Due to the structural nature of the failure, potholes should be repaired using a permanent, full depth replacement patch or base repair.

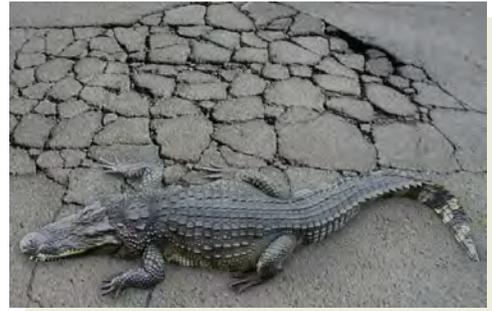
2.3.7 Fatigue Cracking

Fatigue cracking, also known as alligator cracking, typically occurs in asphalt pavement in areas subjected to repeated traffic loadings, such as vehicle wheel paths. This type of crack begins as a series of interconnected cracks which over time slowly connect into many sharp-angled shapes that form a pattern similar to the skin of an alligator. Though it can be caused by a multitude or combination of factors, fatigue cracking is most commonly attributed to a weakened base, subbase, and/or subgrade or insufficient pavement thickness. Due to the structural nature of the failure, full depth base repair or full depth roadway reconstruction in extreme cases is required to repair the damage and prevent the alligator-patterned cracking from resurfacing.

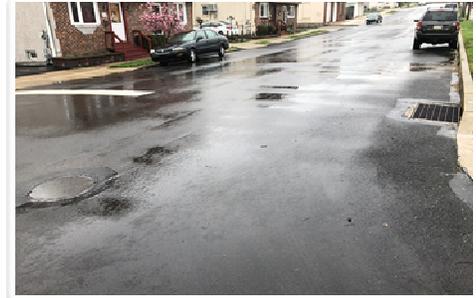
As you can see in the picture to the right, this section of West 11th Avenue between Maple Street and Fayette Street (Blocks 23-26) has no signs of cracking in the roadway surface, the joint sealant around the utilities and along the curb line is clearly visible and the asphalt is a “freshly paved” shade of black. This is a perfect example of a freshly paved roadway that would not require a repair or treatment at this time; however, in the anticipation that this road will require a crack sealing treatment within the timeline of this Infrastructure Management Plan, we have recommended the treatment as such.

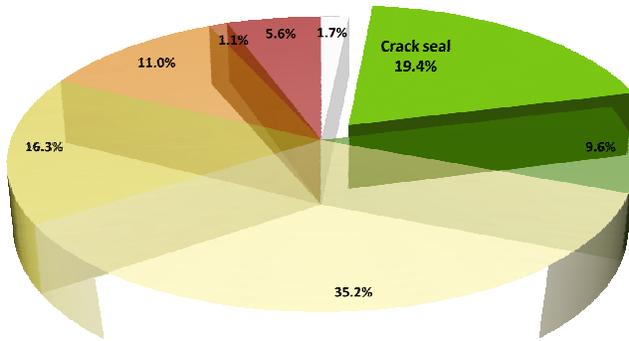
Based upon our condition assessment, we are recommending that 69 of the 355 blocks (19.4%) receive a crack sealing treatment. The pictures below were taken along East Hector Street (Blocks 212-213 and 216-217), Maple Street (Blocks 270-272 and 247-81) and East 3rd Avenue between Harry Street and Hallowell Street (Block 167). These blocks are excellent candidates for crack sealing because the roadway surface is still in generally good condition but is starting to exhibit signs of minor longitudinal and traverse cracking.

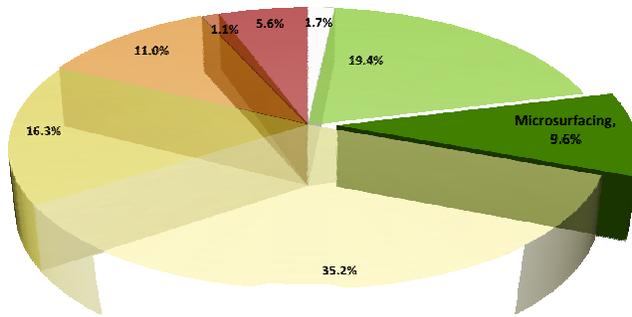
E. 5th Avenue (Wells-Spring Mill)

Based upon our condition assessment, we are recommending that 34 of the 355 blocks (9.6%) receive a micro-surfacing treatment. The pictures below were taken along East 11th Avenue between Hallowell and Wells Streets (Block 31) and East 5th Avenue between Wells Street and Spring Mill Avenue (Block 143). These two blocks are being recommended for micro-surfacing because they are exhibiting signs of raveling/polished aggregate with areas of minor longitudinal or traverse cracking.

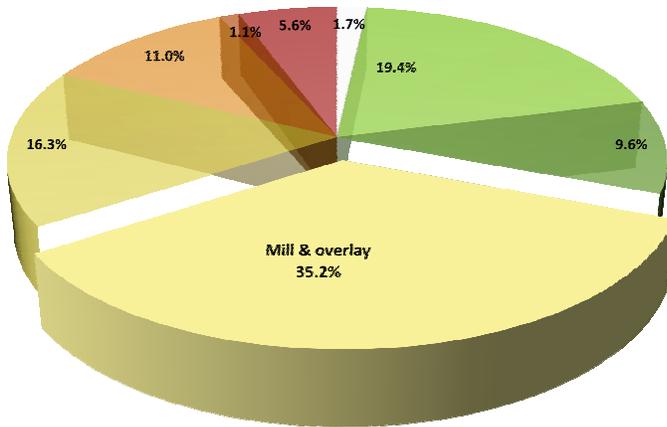
Based upon our condition assessment, we are recommending that 125 of the 355 blocks (35.2%) be treated with a basic mill and overlay. The pictures below were taken along Washington Street between Harry and Ash Streets (Block 234). This block is a perfect example of a road that should be resurfaced. As you can see, there is minor longitudinal cracking, a slight drainage issue by the inlet, and minor settlement along the utility trench. Based on the distresses seen at the pavement surface, it appears that the base and subbase are in good condition.

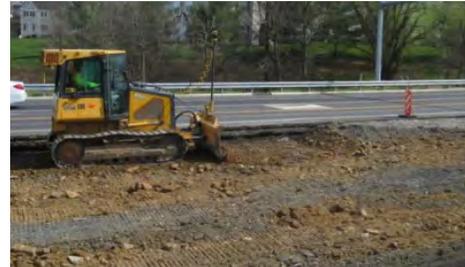
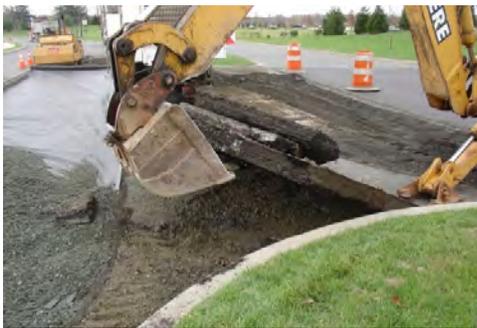
Based upon our condition assessment, we are recommending that 20 of the 355 blocks (5.6%) be fully reconstructed. In addition to the severity of the pavement distress patterns seen in the pictures below taken along Spring Mill Avenue between East 4th Avenue and Cherry Street (Blocks 193-199), the core sampling revealed that these blocks were constructed with less than 2 inches of asphalt. In our professional opinion, the pavement has rapidly deteriorated because it was not designed to withstand the traffic loads it receives. We feel the deterioration has also been accelerated by the improper sealing at the utility trenches, which has allowed water to reach and damage the pavement subbase beyond repair.

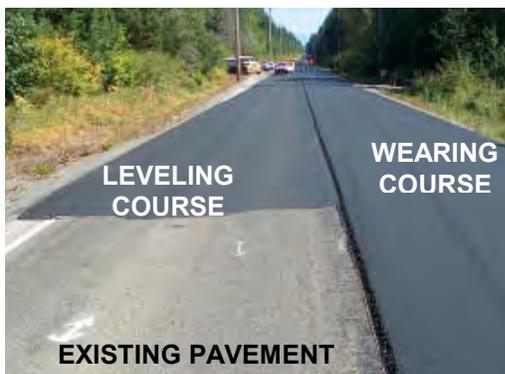
The picture on the previous page is an excellent visual aid demonstrating the relationship between the existing pavement, leveling course, and final wearing course during a roadway resurfacing project. All three pavements layers have labeled for your reference. If you look closely, you will notice that the existing pavement in the bottom left corner is gray and faded and that there is a discernable difference between the thickness of the leveling and wearing courses.

For the purposes of this Infrastructure Management Plan, we are recommending the use of a leveling course for the following reasons: to repair surface deformations such as rutting, to restore the elevation and drainage pattern of the roadway once existing driveway and stormwater plates are removed; to correct minor ponding issues by providing positive drainage; to construct a crown in the roadway to direct water to flow away from the centerline and towards the curbing; and to completely regrade a segment of roadway to accommodate the installation of additional storm sewer structures.

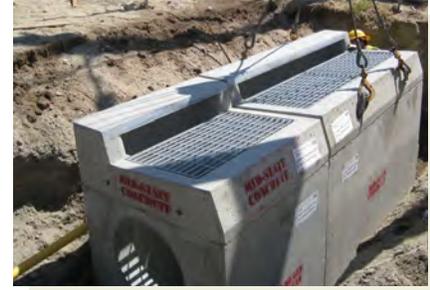
Standard Grate vs Bicycle Safe Grate

While our recommendations for inlet grate and structure replacement will not provide a noticeable improvement to the functionality of the storm sewer system from a drainage standpoint, it will provide a significant improvement for those utilizing non-vehicular forms of transportation on and along the roadways. As you can see from the pictures on the following page, the storm sewer structures themselves can pose several potential safety hazards for bicyclists and pedestrians; such as the wheel of a bicycle getting stuck in the slots of an inlet grate or the top of a city inlet collapsing within the sidewalk. As such, we are recommending that any existing inlet grate that does not meet the dimensional spacing requirements currently deemed safe for bicycles by PennDOT be upgraded to a bicycle safe grate and that all city inlets be removed and replaced with standard inlets to improve pedestrian safety and the efficiency of the structure itself.

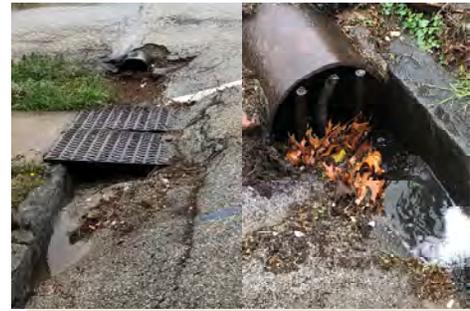
City Inlets vs Standard Inlets

We have also recommended that all surface plates, pipes, and culverts be removed from driveways and intersections and replaced with full depth pavement graded to provide positive drainage. Replacing these structures with graded pavement will remove several areas of observed ponding by directing surface runoff to the nearest inlet. Removing the plates, pipes, and culverts will also eliminate tripping hazards and the potential for these small pipes and channels to become clogged, thus improving the overall efficiency of the system while increasing pedestrian, bicyclist, and motorist safety.

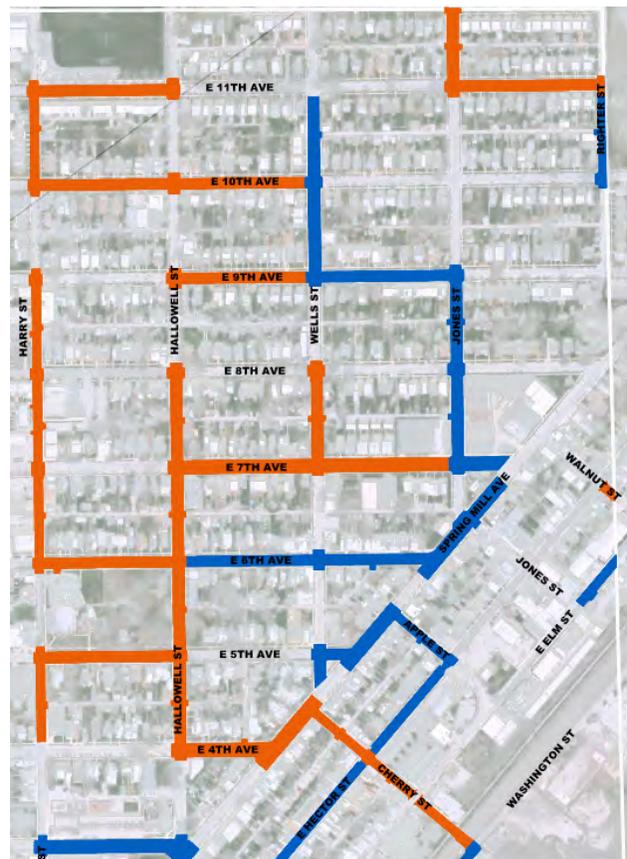
A brief description of each recommended larger scale storm sewer improvement project is provided below and the locations are shown in the accompanying map snapshot. The blocks highlighted in orange represent proposed project while the blue highlights represent blocks with existing storm sewer systems; a Borough-wide copy of this map can be found in Appendix A of this report.

- **East 10th Avenue System:** Expand Wells and Jones Street system to include portions of Harry Street, East 11th Avenue, and East 10th Avenue.
- **Righter Street System:** Expanded to include portions of Jones Street and East 11th Avenue.
- **Harry Street System:** Expand the East 6th Avenue system to extend along include portions of Harry Street.
- **East 6th Avenue & East 4th Avenue Systems:** Reconstruct and resize the systems to accommodate the new flow from the Harry Street System.
- **East 7th Avenue System:** Expand to include portions of Hallowell Street, Wells Street, and East 7th Avenue.
